RESERVE STUDY EXECUTIVE SUMMARY

Client: South Shore Harbour Community Association, Inc. (South Shore Harbour)

Location: League City, Texas

Reference: 071502

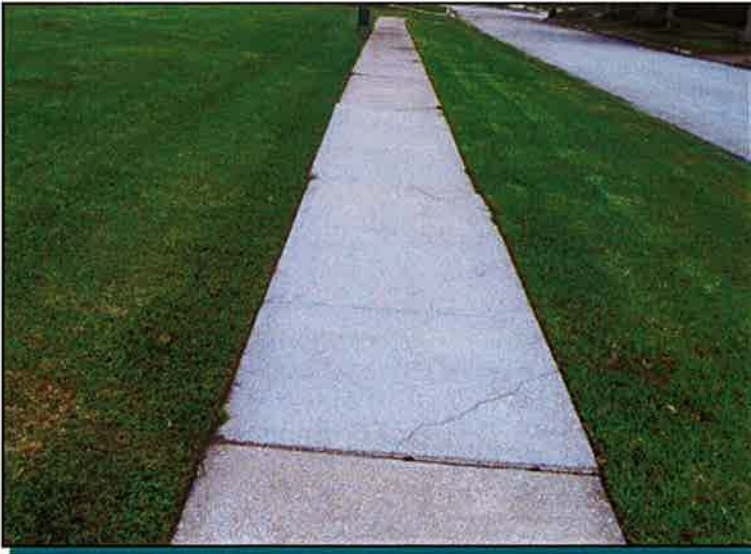
Concrete sidewalks - Note cracks and trip hazards

Concrete Sidewalks - Concrete sidewalks comprise 192,300 square feet throughout the community. This quantity includes the pavilion concrete pad. The sidewalks are in fair to poor overall condition. Our inspection notes trip hazards, cracks

and depressions throughout the concrete sidewalks. Pages 5.2 and 5.3 of *Photographs* depict these conditions. We estimate that up to 155,000 square feet of concrete sidewalks, or eighty-one percent (81%) of the total, will require replacement during the next 30 years. We recommend the Association budget for replacement of 5,000 square feet of concrete sidewalks annually beginning in 2012. Line Item 1 of *Reserve Expenditures* notes our estimate of future costs and anticipated times of replacements. We recommend an annual inspection of the sidewalks to identify potential trip hazards. We suggest that the Association grind down or mark these hazards with orange safety paint prior to replacement and fund this ongoing activity through the operating budget.

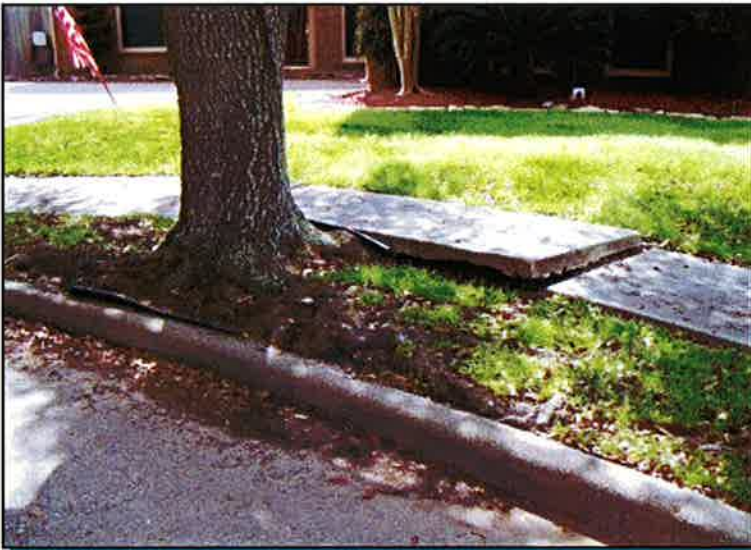
Concrete sidewalks - Note trip hazard

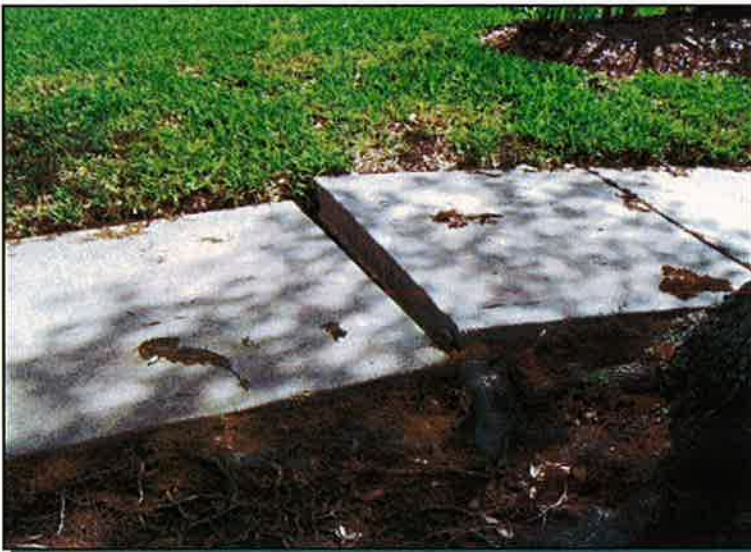
Concrete sidewalks - Note trip hazard

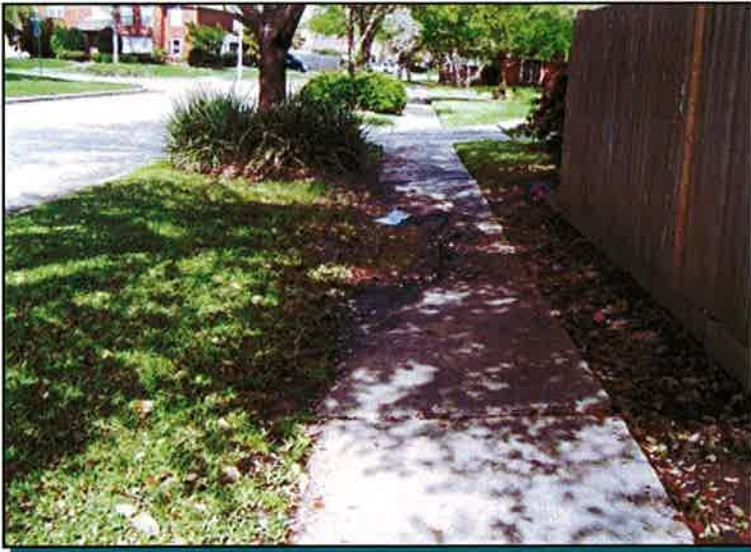
Concrete sidewalks - Note trip hazard and depression

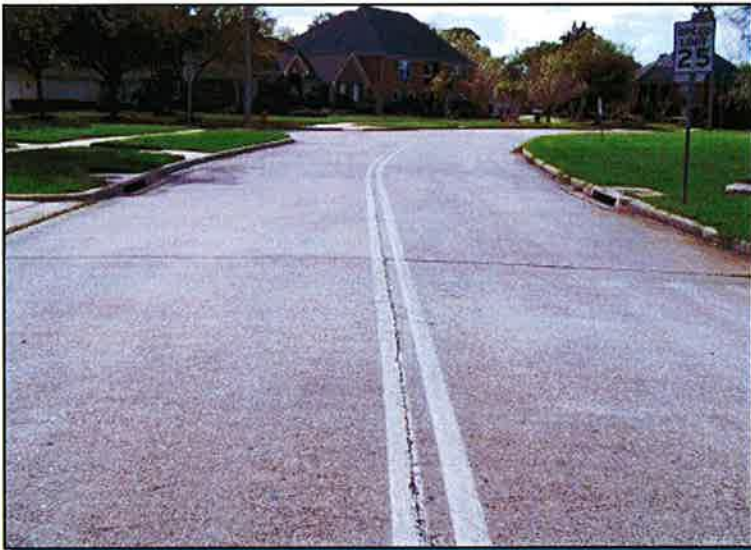
Concrete street

Concrete Streets - The Association maintains approximately 1,400,000 square feet of concrete at the private streets. This quantity includes the concrete curbs and the parking lot at the pool. The streets are in good to fair overall condition at an age of 30 years. Our inspection notes missing curb sections, and damage and cracks in the concrete streets. Pages 5.3 through 5.5 of *Photographs* depict these conditions. Concrete streets have a useful life of up to 65 years. We estimate that up to 480,000 square feet of concrete streets, or thirty-four percent (34%) of the total, will require replacement during the next 30 years. We advise the Association budget for the replacement of 32,000 square feet of the streets every four years beginning by 2017 followed by a steadily increasing rate of replacement as the streets continue to age. Line Item 2 of *Reserve Expenditures* notes our estimate of future costs and anticipated times of replacements.

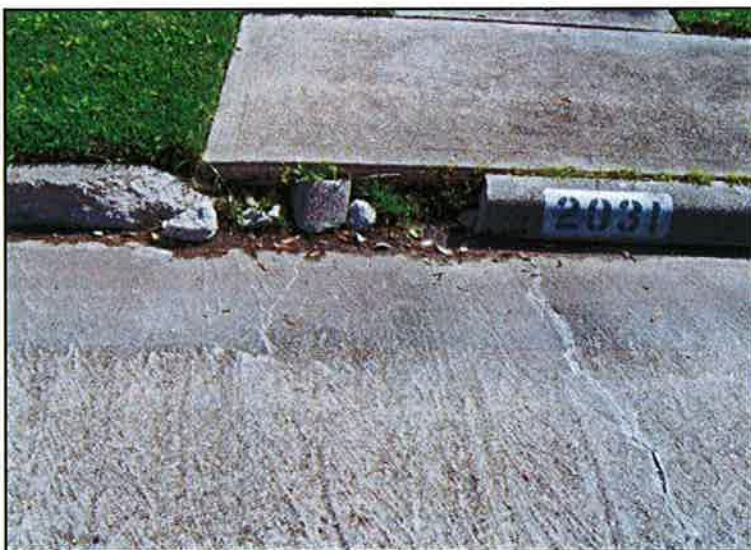
Concrete curb - Note missing section

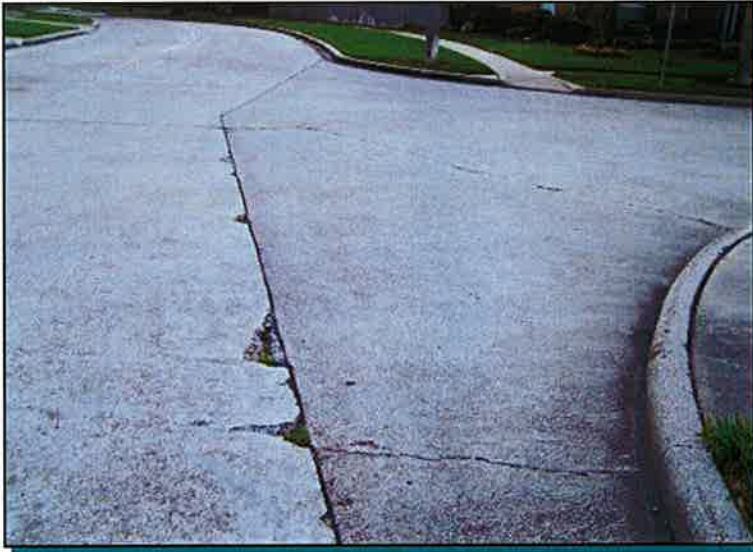
Concrete streets - Note cracks and damage

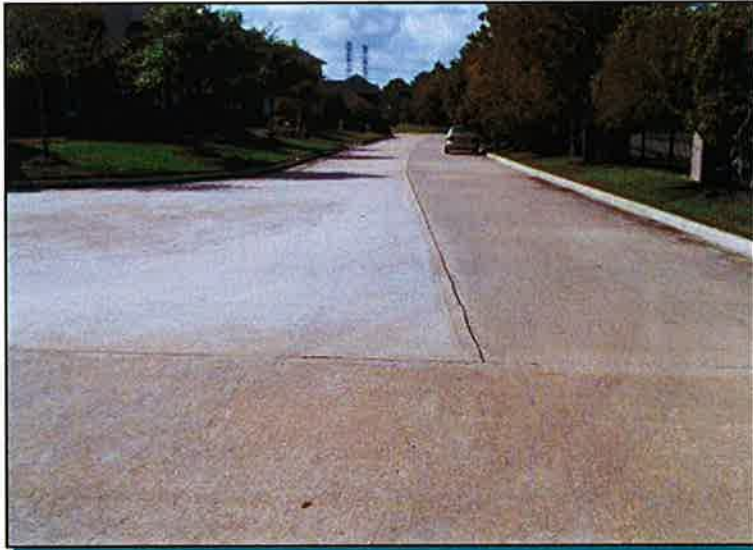
Concrete street

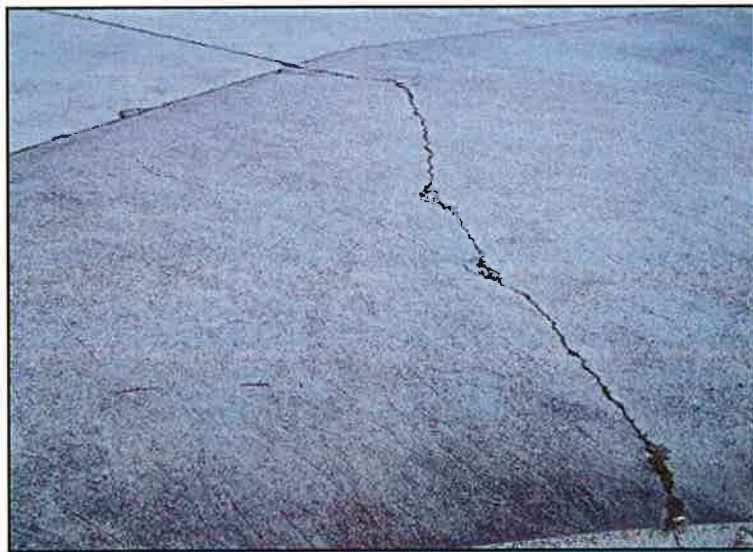
Concrete street - Note cracks

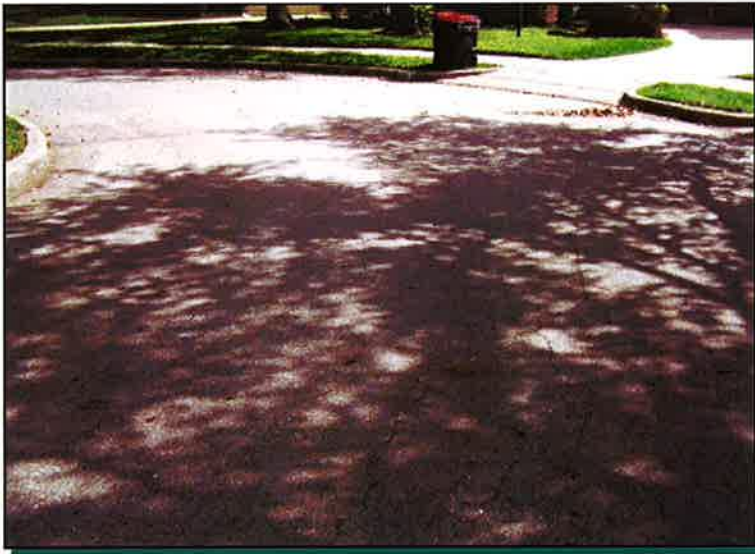
Concrete street - Note cracks

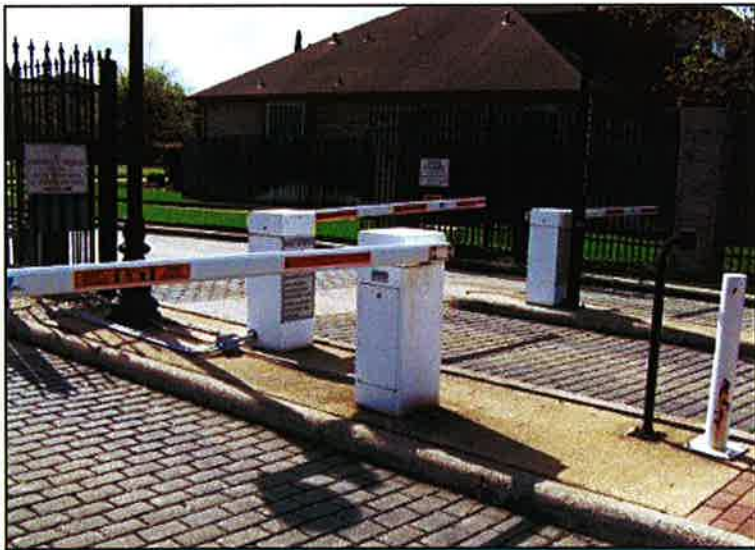
Swing arm operators

Entrances, Swing Arm Operators - South Shore Harbour maintains 24 swing arm operators that limit access into the community. The swing arm operators are in fair condition at unknown ages. These elements have a useful life of up to 10 years. We recommend the Association budget for phased replacement of up to fifty percent (50%) beginning by 2013 and every five years thereafter. We depict this information on Line Item 4 of ***Reserve Expenditures***. The Association should replace damaged swing arms as needed through the operating budget.

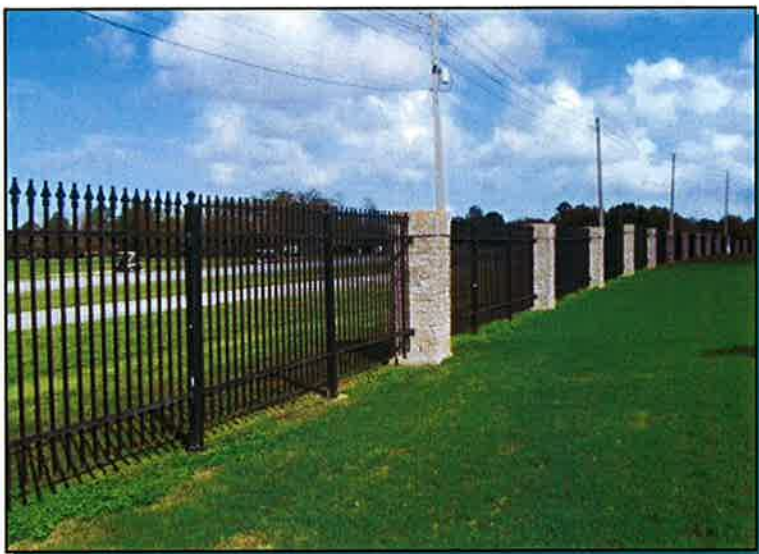
Metal fences and masonry pillars

maintenance free. Periodic maintenance should include periodic applications of protective paint finish to the metal fences and partial replacement of deteriorated fence sections as needed. Fence components at grade and key structural connections are especially prone to failure if not thoroughly maintained. Secure and rust free fasteners and connections will prevent premature deterioration. The protective finishes are in fair to poor overall condition. Our inspection notes finish deterioration on the metal fences. Page 5.6 of *Photographs* depicts this condition. We recommend paint applications every six- to eight-years and we anticipate a useful life of up to 60 years for the fences. Therefore, we do not anticipate the need for replacement of the newer sections of metal fences during the next 30 years.

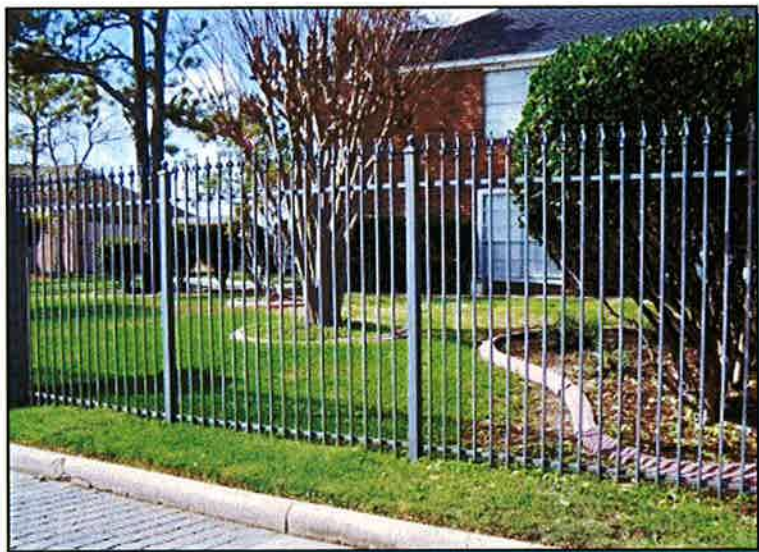
Metal fence

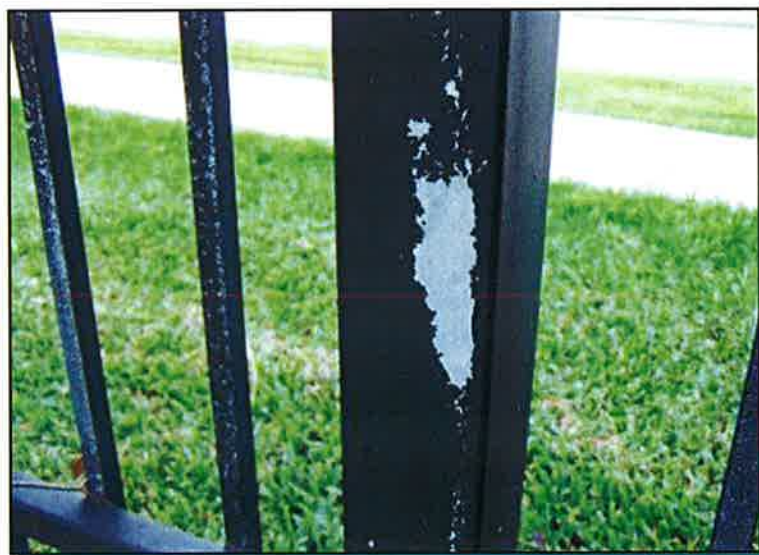
Metal fence - Note paint finish deterioration

Periodic applications of paint to the fences will help prevent the need to budget for their costly replacement. Preparation of the fences before application of the paint finish is important. The painting contractor should remove all soil, dirt, oil, grease and other foreign materials before application of the paint finish to maximize its useful life. The contractor should also remove paint blisters and rust prior to the paint finish application. We recommend the use of a power wire brush, scraper and/or sander as effective means of removal. The Association should require the application of a primer on bare metal. The primer for metal surfaces should include a rust inhibitor for added protection. We recommend the Association refinish the fences by 2015 and every eight years thereafter. We anticipate replacement of the 1,360 linear feet of older section of metal fences by 2038, therefore these fence sections will not require paint applications in 2038. We detail this information on Line Items 5 through 7 of *Reserve Expenditures*.

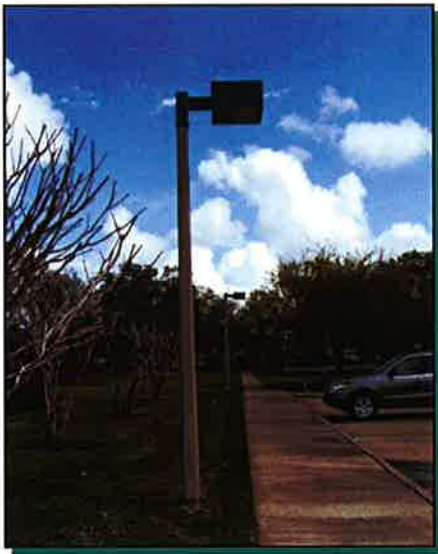
Light pole and fixture

Light Poles and Fixtures - The Association uses six metal light fixtures atop five concrete poles to illuminate the property. The poles and fixtures are in good overall condition at an unknown age. Exterior light poles and fixtures have useful lives of up to 25 years. The Association should anticipate the need to replace the poles and fixtures by 2023. We note this information on Line Item 8 of *Reserve Expenditures*.

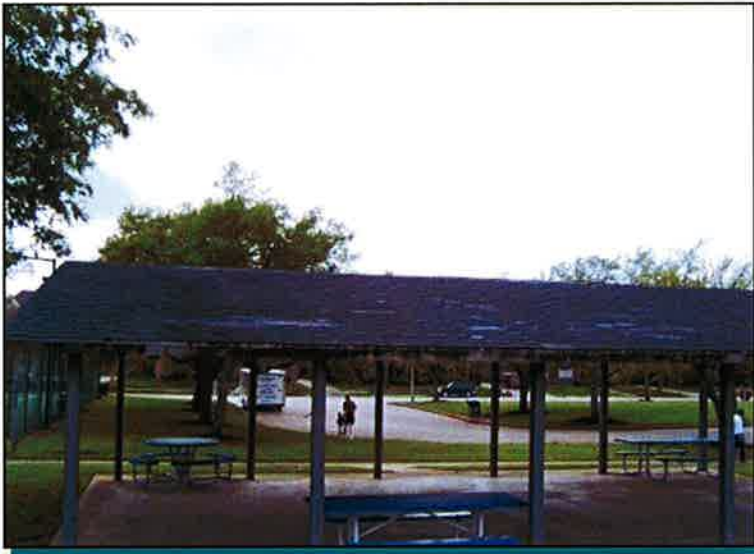
Pavilion

Pavilion - The Association maintains a metal frame pavilion with an asphalt shingle roof at the recreation park. The pavilion is in good condition at an unknown age. Pavilion structures have a useful life of up to 25 years. We recommend South Shore Harbour budget for its replacement by 2023 and budget for repairs to the pavilion, interim replacements of the pavilion

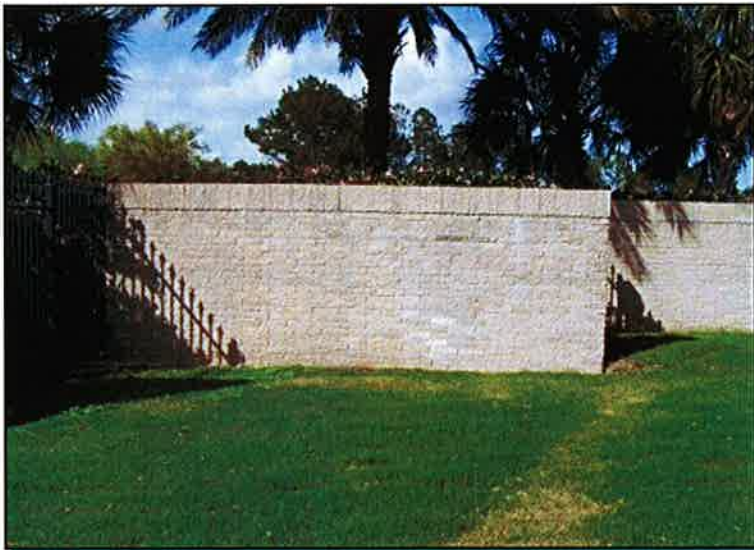
Masonry walls

Perimeter Pillars and Walls, Masonry - The Association maintains approximately 32,200 square feet of masonry pillars and perimeter walls throughout the community. This quantity includes both sides of the walls. The overall condition of the masonry is good at an age of 30 years. Masonry generally requires less maintenance than other types of exterior elements. However, masonry is not maintenance free. South Shore Harbour should plan for the periodic inspection of the masonry to identify and repair areas of deterioration. Common types of masonry deterioration include efflorescence, spalling and cracking.

Repointing is a process of raking and cutting out defective mortar to a depth of not less than ½ inch nor more than ¾ inch and replacing it with new mortar. We advise a complete inspection of the pillars and perimeter walls, and partial repointing with related masonry repairs every 8- to 12-years to forestall deterioration. We suggest that the Association budget for repointing of up to six percent (6%), or about 1,930 square feet of masonry, by 2014 and every 10 years thereafter. We depict this information on Line Item 11 of *Reserve Expenditures*.

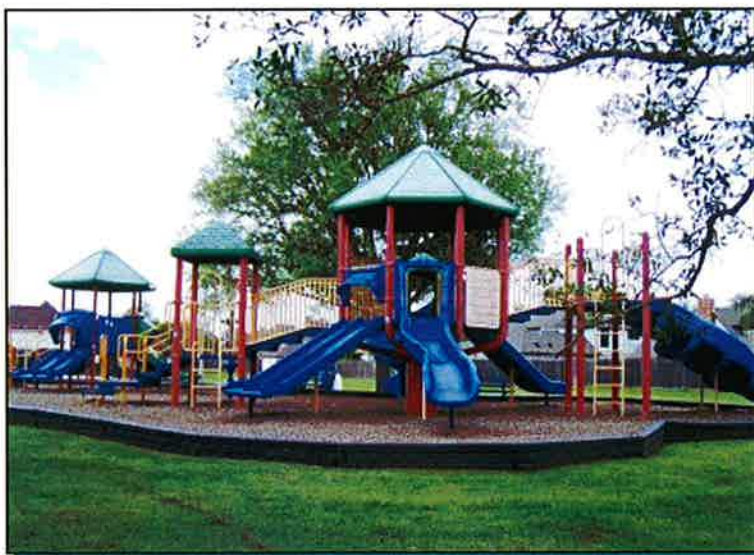
Playground equipment

Playground Equipment - The Association maintains playground equipment at the recreation park. The playground equipment is in good condition at an age of 13 years. Safety is the major purpose for maintaining playground equipment. We recommend an annual inspection of the playground equipment to identify and repair as normal maintenance loose connections and fasteners or damaged elements. *Playworld Systems*¹ is a leading innovator of modular

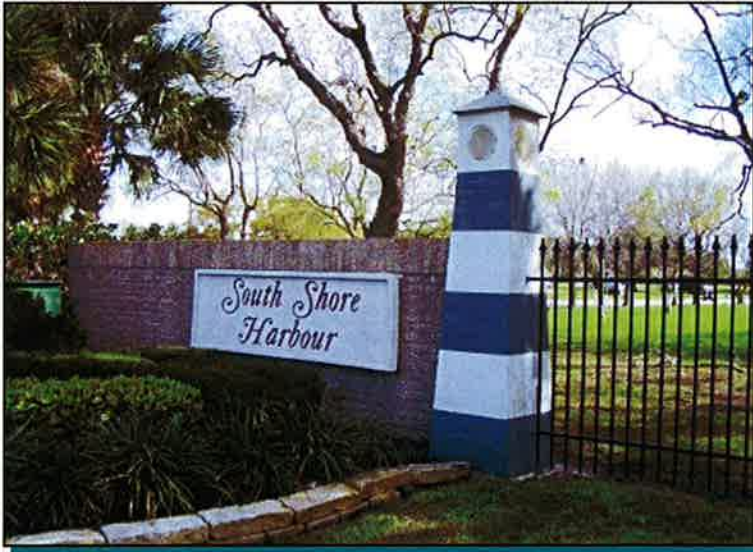
Signage

Signage, Entrance Monuments - The Association maintains five entrance monuments throughout the community. Two entrance monuments comprise wood and brick masonry. The remaining three monuments comprise brick masonry, composite sign boards and concrete pillars. These monuments are in good to fair condition at unknown ages. The community signs contribute to the overall aesthetic appearance to owners and potential buyers. We advise the Association conduct capital repairs to the masonry and concrete, and replace the wood and composite signs every 20 years. We recommend the Association plan to renovate the entrance monuments by 2016 and again by 2036. We note this information on Line Item 13 of *Reserve Expenditures*.

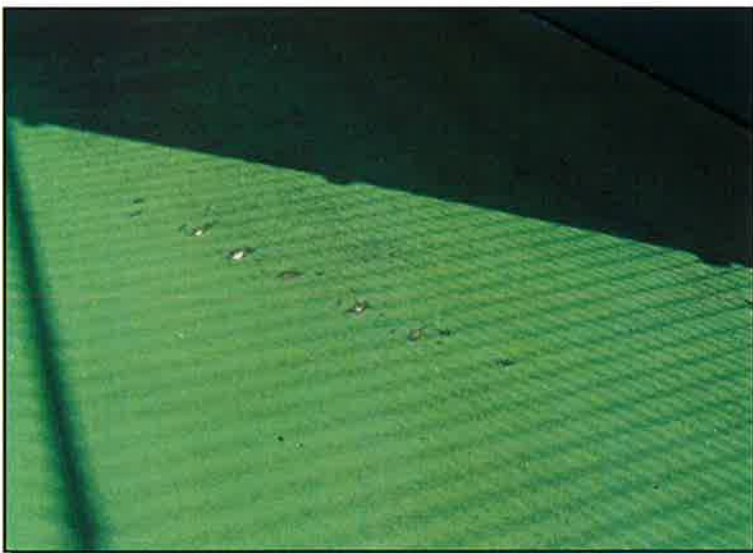
Tennis courts - Note color coat deterioration

Color Coat and Boundary Lines - The tennis court color coat surface and the painted boundary lines on the basketball court are in overall good condition at an age of five years. Our inspection notes minor color coat deterioration. Page 5.9 of ***Photographs*** depicts this condition. We recommend the Association apply a new color coat to the concrete tennis courts and paint boundary lines to the concrete basketball court every four- to six-years to maximize the useful life of the courts. Prior to the application of the color coat and boundary lines, the Association should require the contractor to rout and fill all cracks. This deters water infiltration and further deterioration of the concrete playing surfaces. We advise the Association to perform crack repairs and apply a new color coat to the concrete tennis courts and paint boundary lines on the concrete basketball court in 2013 and every six years thereafter except when replacement occurs. We include this information on Line Item 14 of ***Reserve Expenditures***.

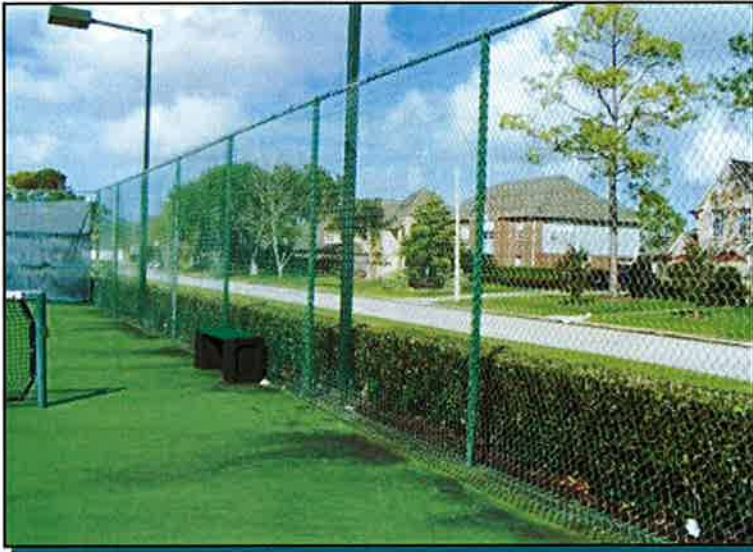
Tennis courts fence

Fence - Approximately 430 linear feet of metal chain link fence enclose the tennis courts. The chain link fence is in good condition at an unknown age. Chain link fence of this type has a useful life of 15- to 25-years. We recommend the Association anticipate replacement of the court chain link fence by 2031, concurrent with concrete surface replacement. We depict this information on Line Item 16 of *Reserve Expenditures*.

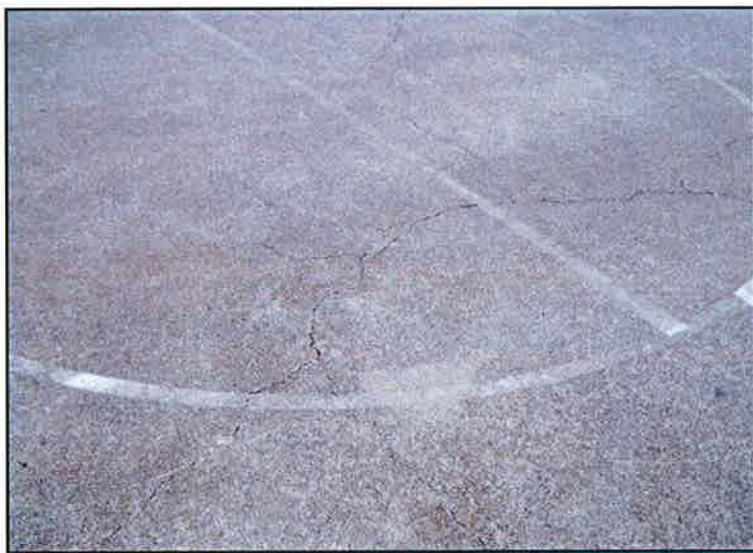
Basketball court - Note cracks

Surface - The court playing surfaces are in good to fair overall condition at an age of 30 years. Our visual inspection notes cracks in the concrete basketball court. Page 5.10 of ***Photographs*** depicts this condition. These courts are subject to soil movements and have useful lives of up to 40 years. In consideration of the observed good to fair condition of the courts, we recommend the Association defer the initial surface replacement and anticipate replacement of the courts by 2031. We note this information on Line Item 15 of ***Reserve Expenditures***. We recommend replacement of the tennis standards and basketball goals from the operating budget on an as needed basis.

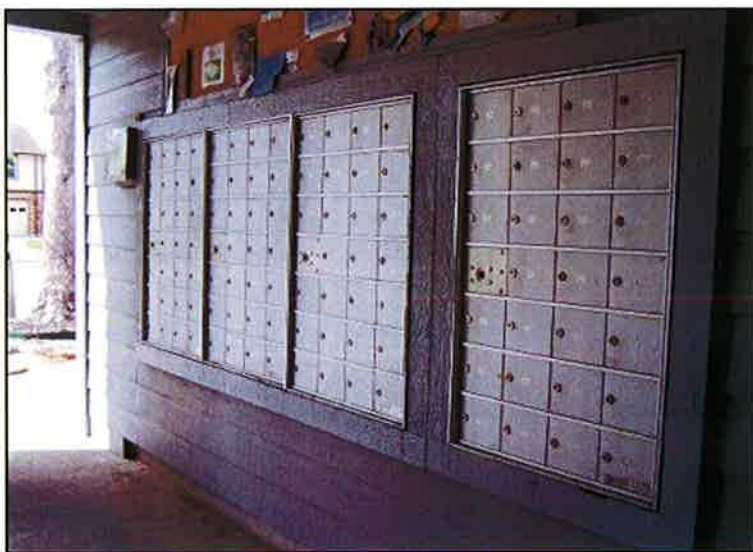
Mailboxes

Mailboxes - A total of 776 unit mailboxes are located in the recreation area mailbox kiosk building of South Shore Harbour. The mailboxes are in good overall condition at an age of two years. Mailboxes of this type have useful lives of up to 30 years. We recommend the Association anticipate replacement of the mailboxes by 2040. We include this information on Line Item 18 of *Reserve Expenditures*. The Association should verify the new mailboxes meet

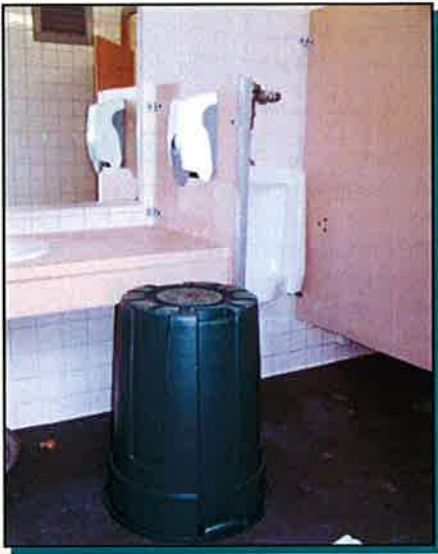
Rest room overview

Rest Rooms, Renovations - The Association maintains two common area rest rooms located in the pool house. The components of these rest rooms include ceramic tile walls, painted ceilings, concrete floors with a rubber floor covering, various light and plumbing fixtures, and toilet partitions. The components are in overall fair to poor condition at an age of 30 years. Periodic renovations of the rest rooms are an astute practice to maintain a positive overall appearance of the Association. The useful life of rest room components varies up to 30 years. Management informs us the Association will renovate the rest rooms in 2012. We recommend the Association budget for a subsequent renovation of the rest rooms by 2042. We include an allowance of \$5,000 plus inflation per rest room on Line Item 19 of *Reserve Expenditures* for these renovations. The Association should verify the rest room renovations comply with the Americans with Disability Act (ADA).

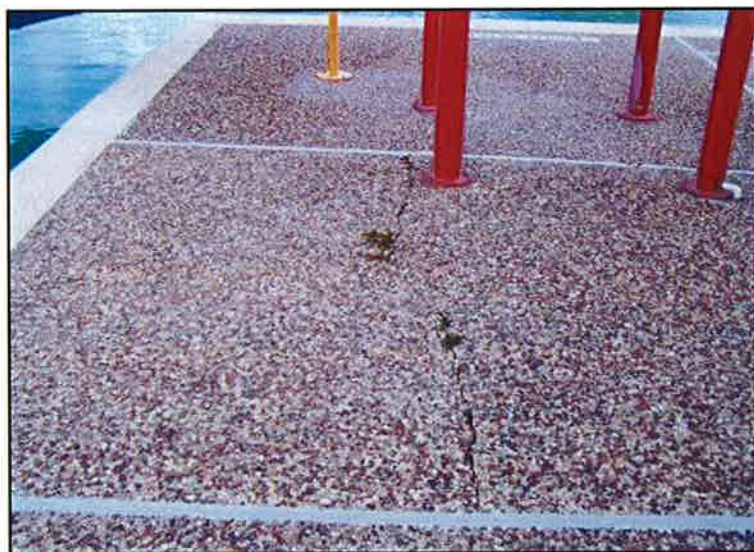
Concrete deck - Note cracks

Concrete Deck - An exposed aggregate concrete deck surrounds the pool and wading pool. The pool deck comprises approximately 6,850 square feet of concrete. The deck is in good to fair condition at an age of 30 years. Our inspection notes cracks in the concrete deck. Page 5.12 of *Photographs* depicts this condition. The useful life of a concrete pool deck is up to 60 years. However, we recommend the Association conduct inspections, partial replacements and repairs to the deck every 8- to 12-years. Soil movement and water infiltration underneath the concrete deck can cause significant settlement and cracks in the concrete. The pool deck should

also be free of trip hazards for the safety of residents and their guests. We recommend the Association plan partial replacements of up to ten percent (10%) of concrete sections, crack repairs, mortar joint repairs and caulk replacement beginning by 2018 and again by 2028. The times, amounts and related costs of these repairs and replacements may vary. However, we judge the amounts shown on Line Item 20 of *Reserve Expenditures* sufficient to budget appropriate reserves.

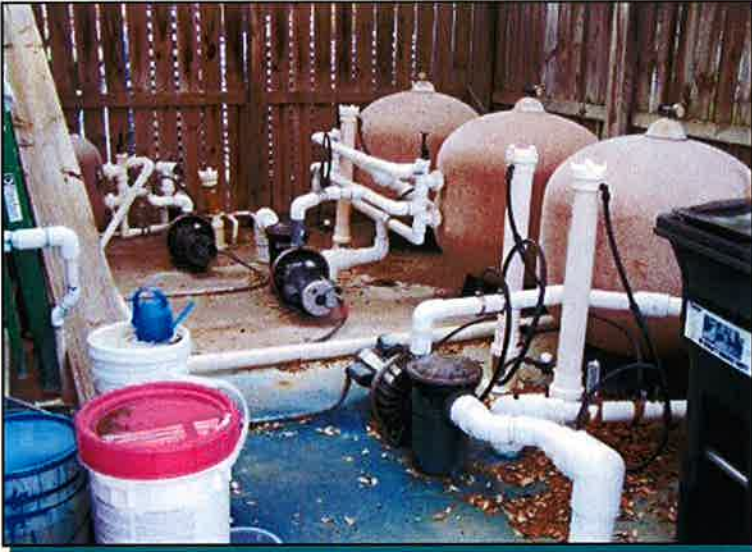
Mechanical equipment

The pool mechanical equipment is in fair to poor condition at unknown ages. Pool mechanical equipment has a useful life of 12- to 15-years. We recommend the Association anticipate replacement of the pool mechanical equipment in 2013 and every 12 years thereafter. We consider interim replacement of motors and minor repairs as normal maintenance. We note this information on Line Item 21 of *Reserve Expenditures*.

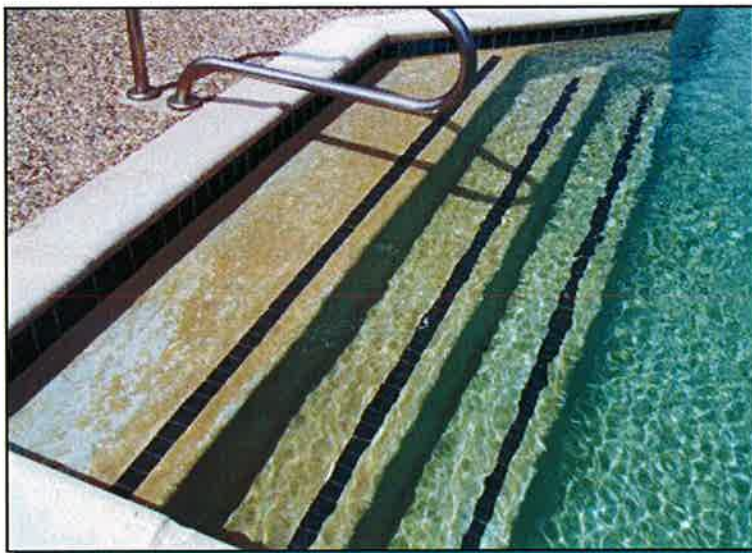
Plaster finish - Note deterioration
